LIGHTNING EFFECTS RELATING TO AIRCRAFT
PART I - LIGHTNING EFFECTS ON AND ELECTROMAGNETIC
SHIELDING PROPERTIES OF BORON AND GRAPHITE
REINFORCED COMPOSITE MATERIALS

F.A. Fisher
High Voltage Laboratory
General Electric Company

Technical Report AFAL-TR-72-5

January 1972

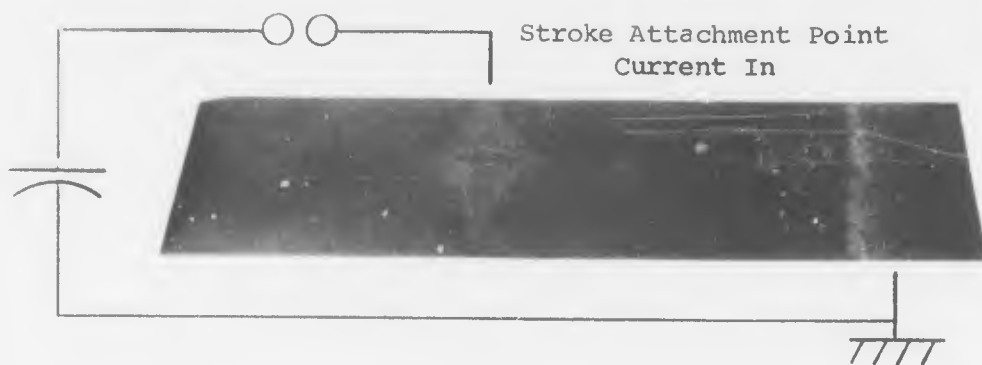
L-13C
30.6 kA
Positive Polarity

A photograph of the damage to this panel is shown on Figure 3. On this uncoated sample the damage was confined mostly to the arc attachment point. At this point there was a diamond-shaped burn approximately 1.2" wide along the long axis of the sample and about 2.7" wide transverse to the sample axis. Fibers were lifted on both the top ply and the ply

FIGURE 3 - Damage to Uncoated Samples

The previous samples were tested with a positive polarity discharge, one involving electron flow from the arc attachment point into the high voltage electrode and into the generator. Sample L-15A was tested with a negative polarity discharge, one with electron flow from the electrode into the arc attachment point in order to see if polarity effects made any difference. They did not. Damage was virtually identical to that observed on Sample L-13A at the same current level. A photograph of this panel is also shown on Figure 3.

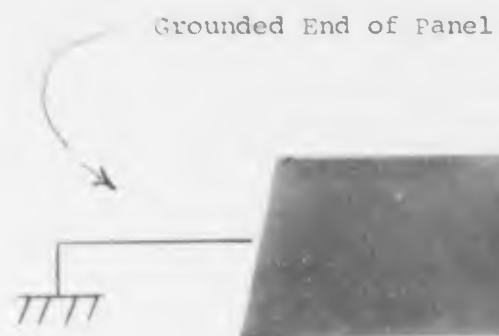
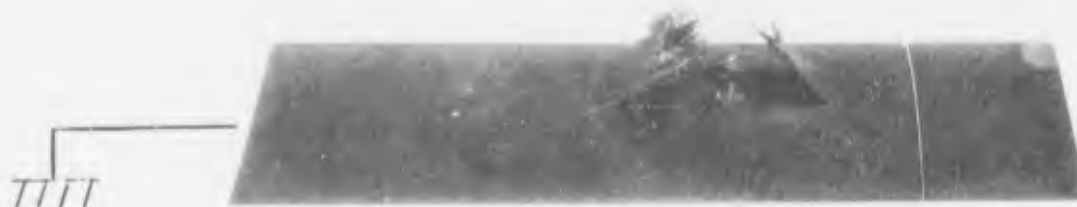
FIGURE 4 - Typical Damage to Carbon or Salt-Loaded Coatings

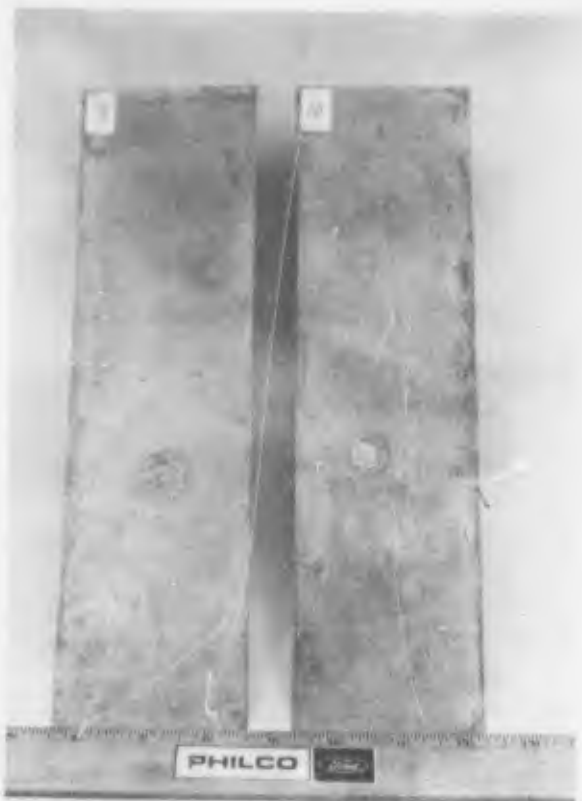
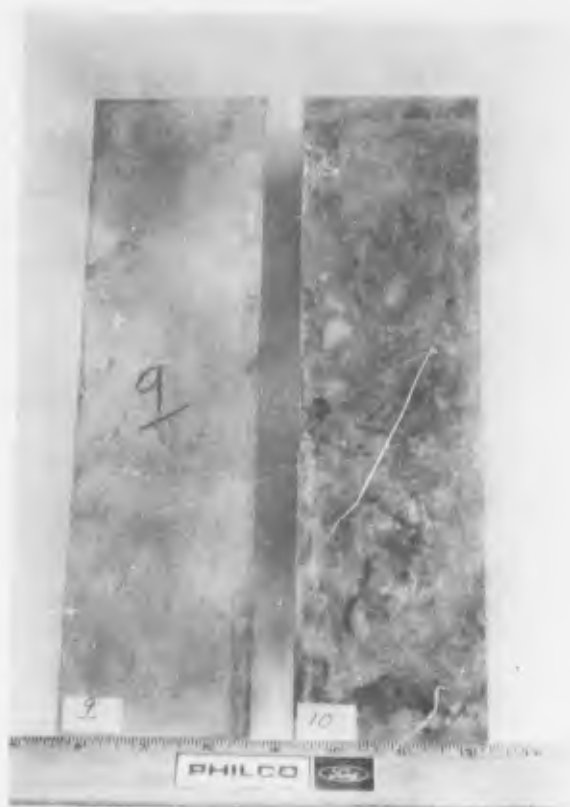
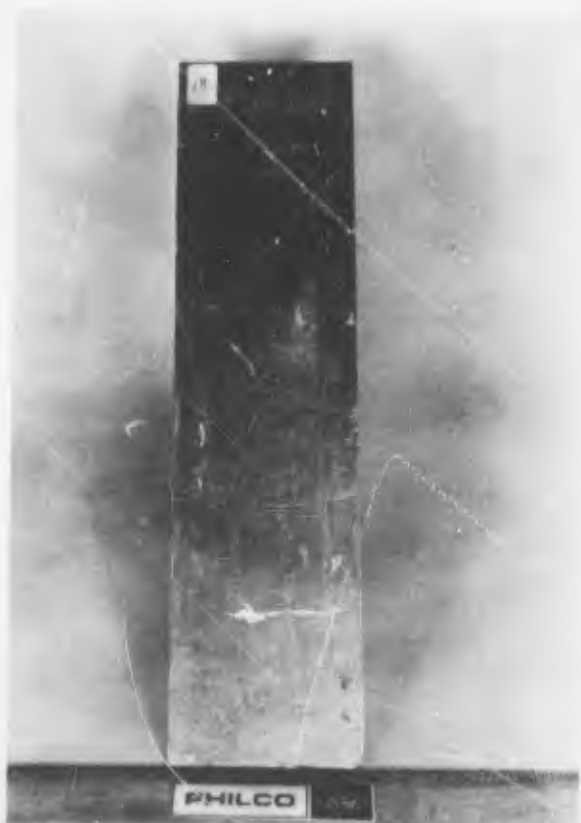
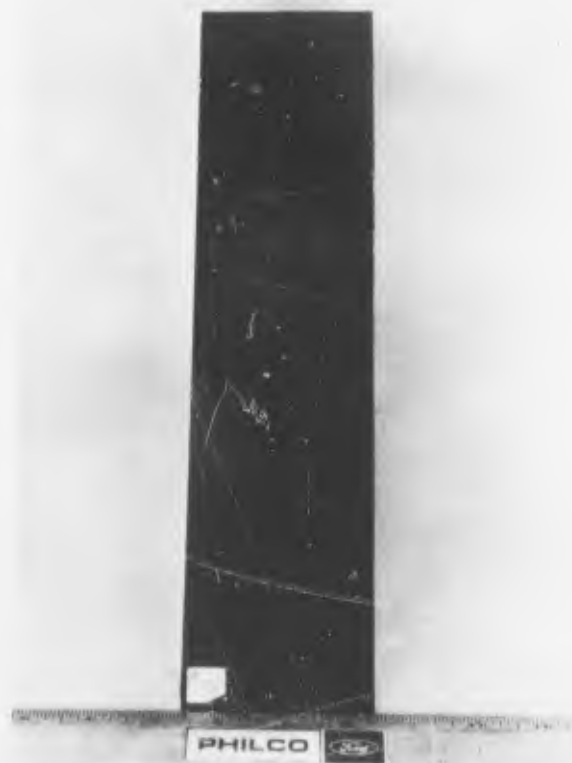
FIGURE 5 - Damage to Surfaces of Metal Coated Panels

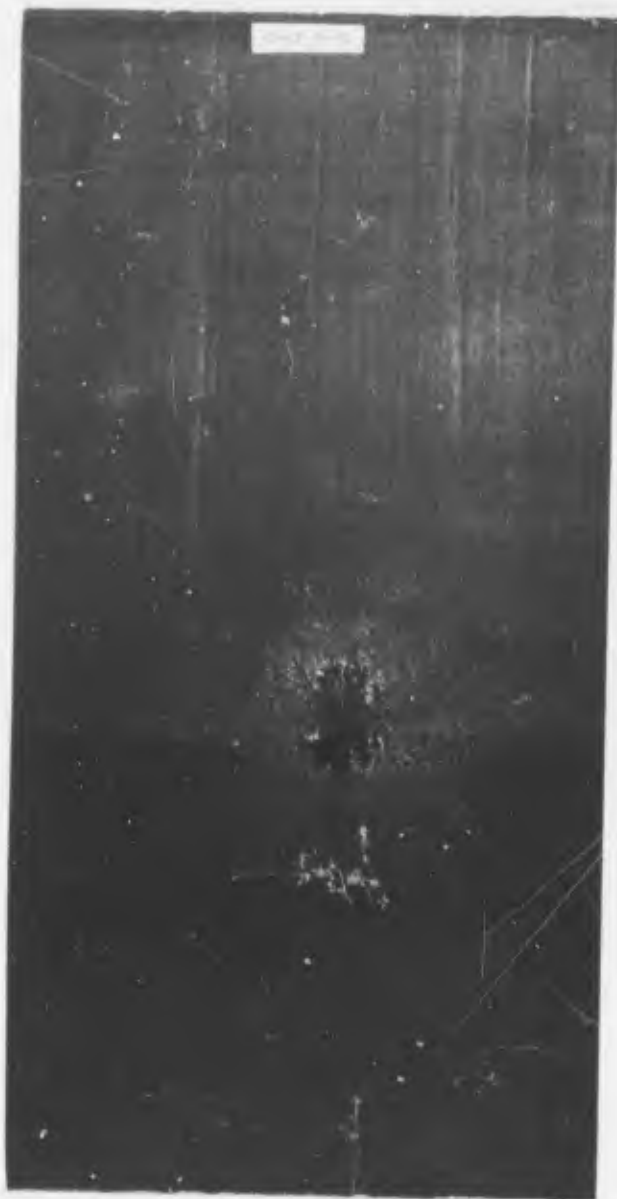
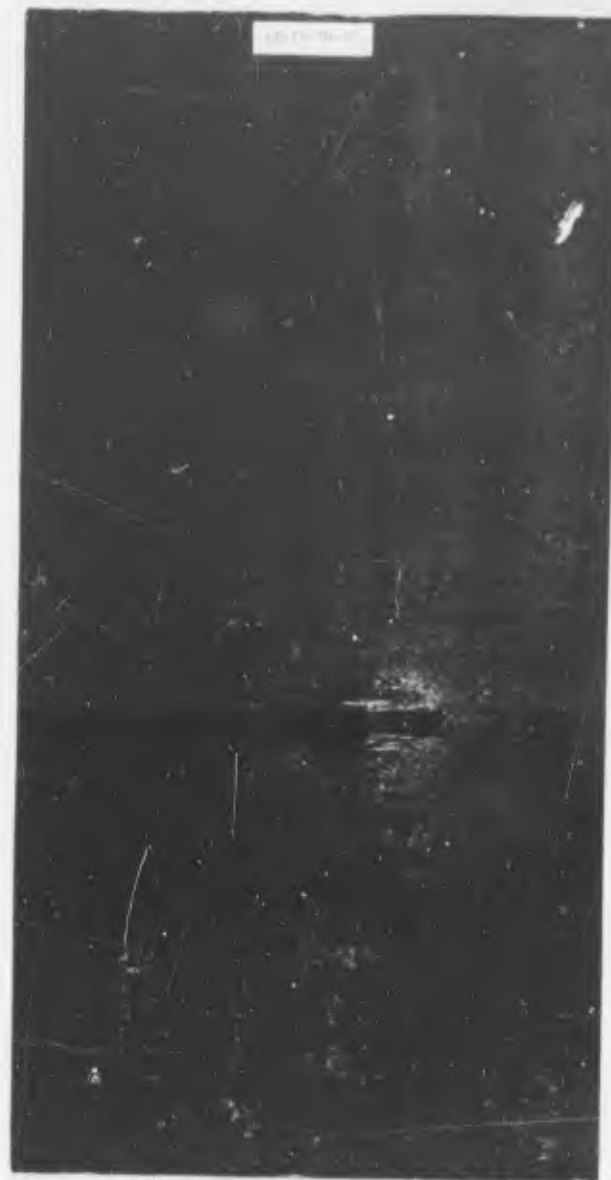
This sample was tested at approximately the 60 kA critical threshold level observed on the 3" x 12" sample discussed in the previous section. A photograph of the damaged panel is shown on Figure 12. In a manner somewhat similar to that observed on the three-inch panels there is a region at the arc attachment point at which the arc completely destroyed fibers and lifted fibers from the board. Around this there is a region where the resin has apparently been heated sufficiently to cause a change in its appearance. At the grounded end of the sample there is a region in which additional damage was caused by current flowing out of the panel into the ground return circuit. Between the two there is a region that does not appear to be visually damaged. The area in which fibers were completely destroyed is an oval of about 1 inch length and 0.6 inch width. The region over which the resin was discolored was about a 3 inch diameter circle. On the three-inch samples one noted a significant effect caused by the ply orientation in that current apparently flowed from the top ply into the one underneath it and then out at right angles to the length of the sample. This caused the damaged region to be wider than it was long in the direction

FIGURE 12 - Appearance of Uncoated Graphite Composite Panels After Simulated Lightning Tests

A photograph of this panel after test is also shown on Figure 12. Differences are that the area of total destruction of fibers is a bit larger, an oval of about 1.6" x 0.8" and that the pyrolyzed region of resin surrounding the stroke attachment point extends almost down to the grounded end of the sample. The panel was not punctured by the arc.

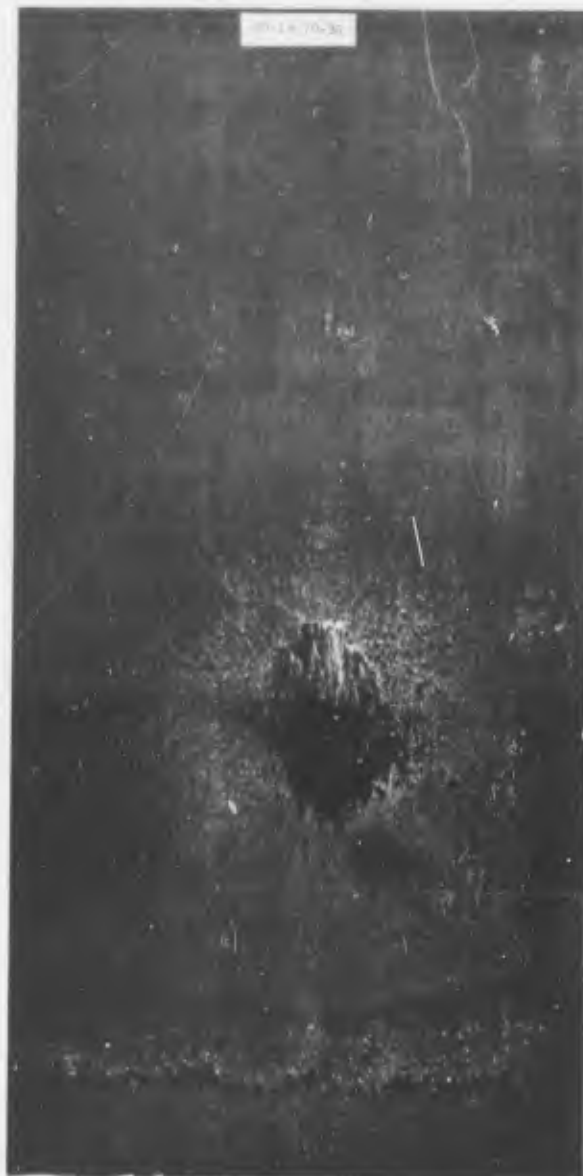
GD-LS-70-3G
(142 kA)

A photograph of this panel is shown on Figure 13. The area of fiber damage is again an oval of 2 inches x 1.4 inches. The pyrolyzed region again extends almost all the way down to the grounded end of the panel. The panel was not punctured.

FIGURE 13 - Appearance of Uncoated Graphite Composite Panel After
Simulated Lightning Test

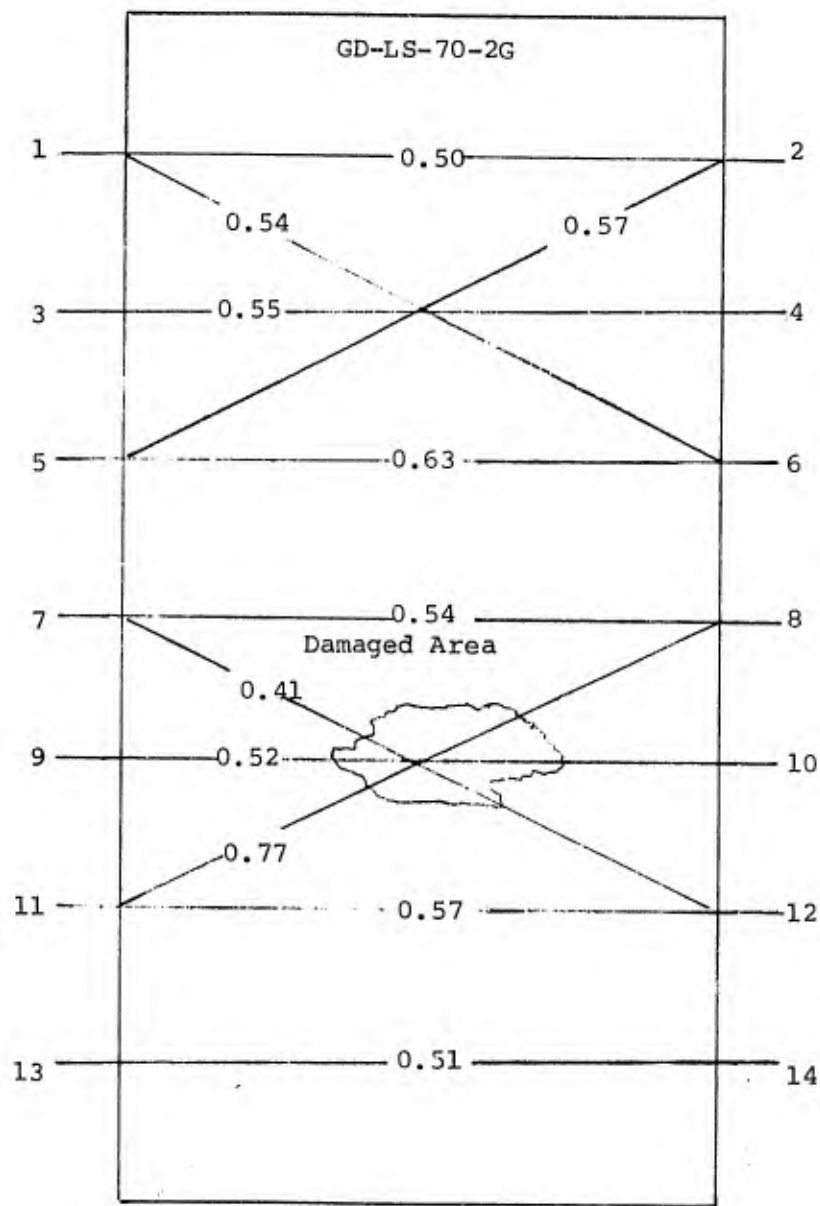
Accordingly, while resistance measurements may be valuable for detecting damage in individual graphite fibers, they do not appear a promising method of evaluating damage on a laid-up graphite composite panel.

FIGURE 16 - Resistance Measurements on Graphite Composite Panel GD-LS-70-2G
(Resistance Values in Ohms)

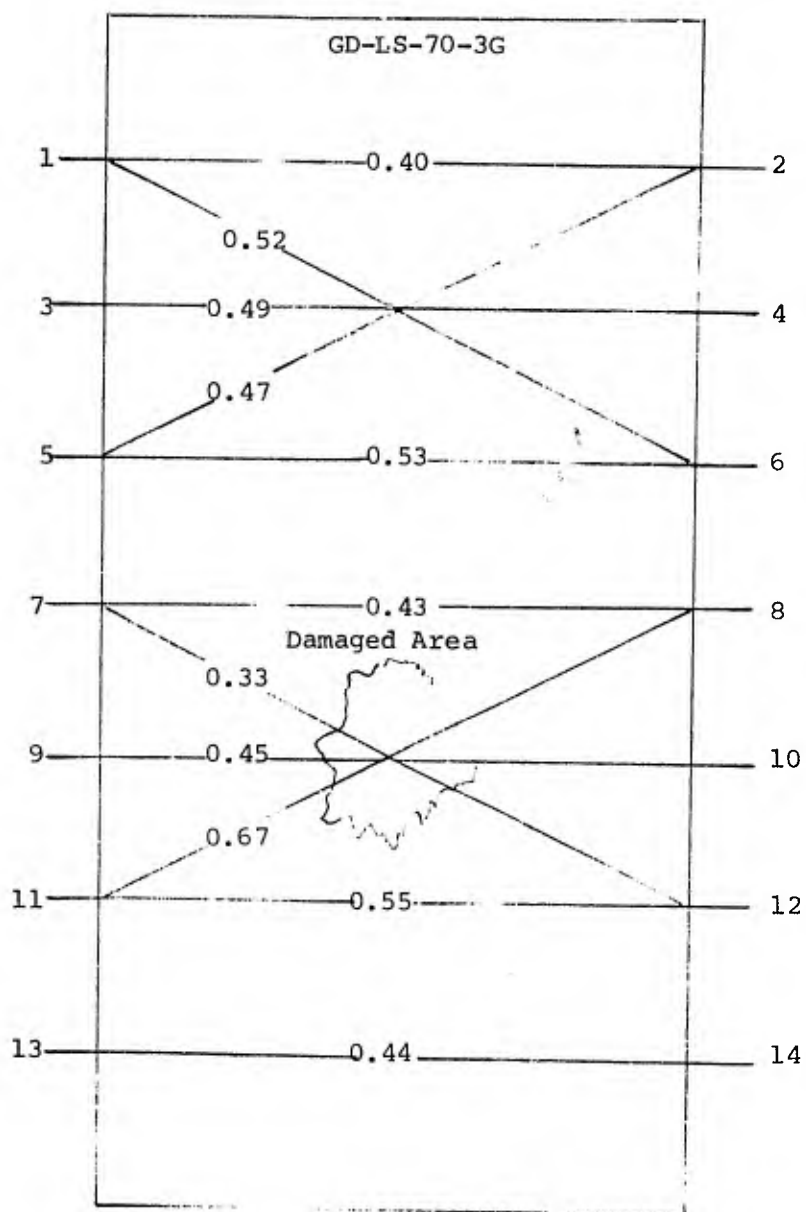
FIGURE 17 - Resistance Measurements on Graphite Composite Panel GD-LS-70-3G
(Resistance Values in Ohms)

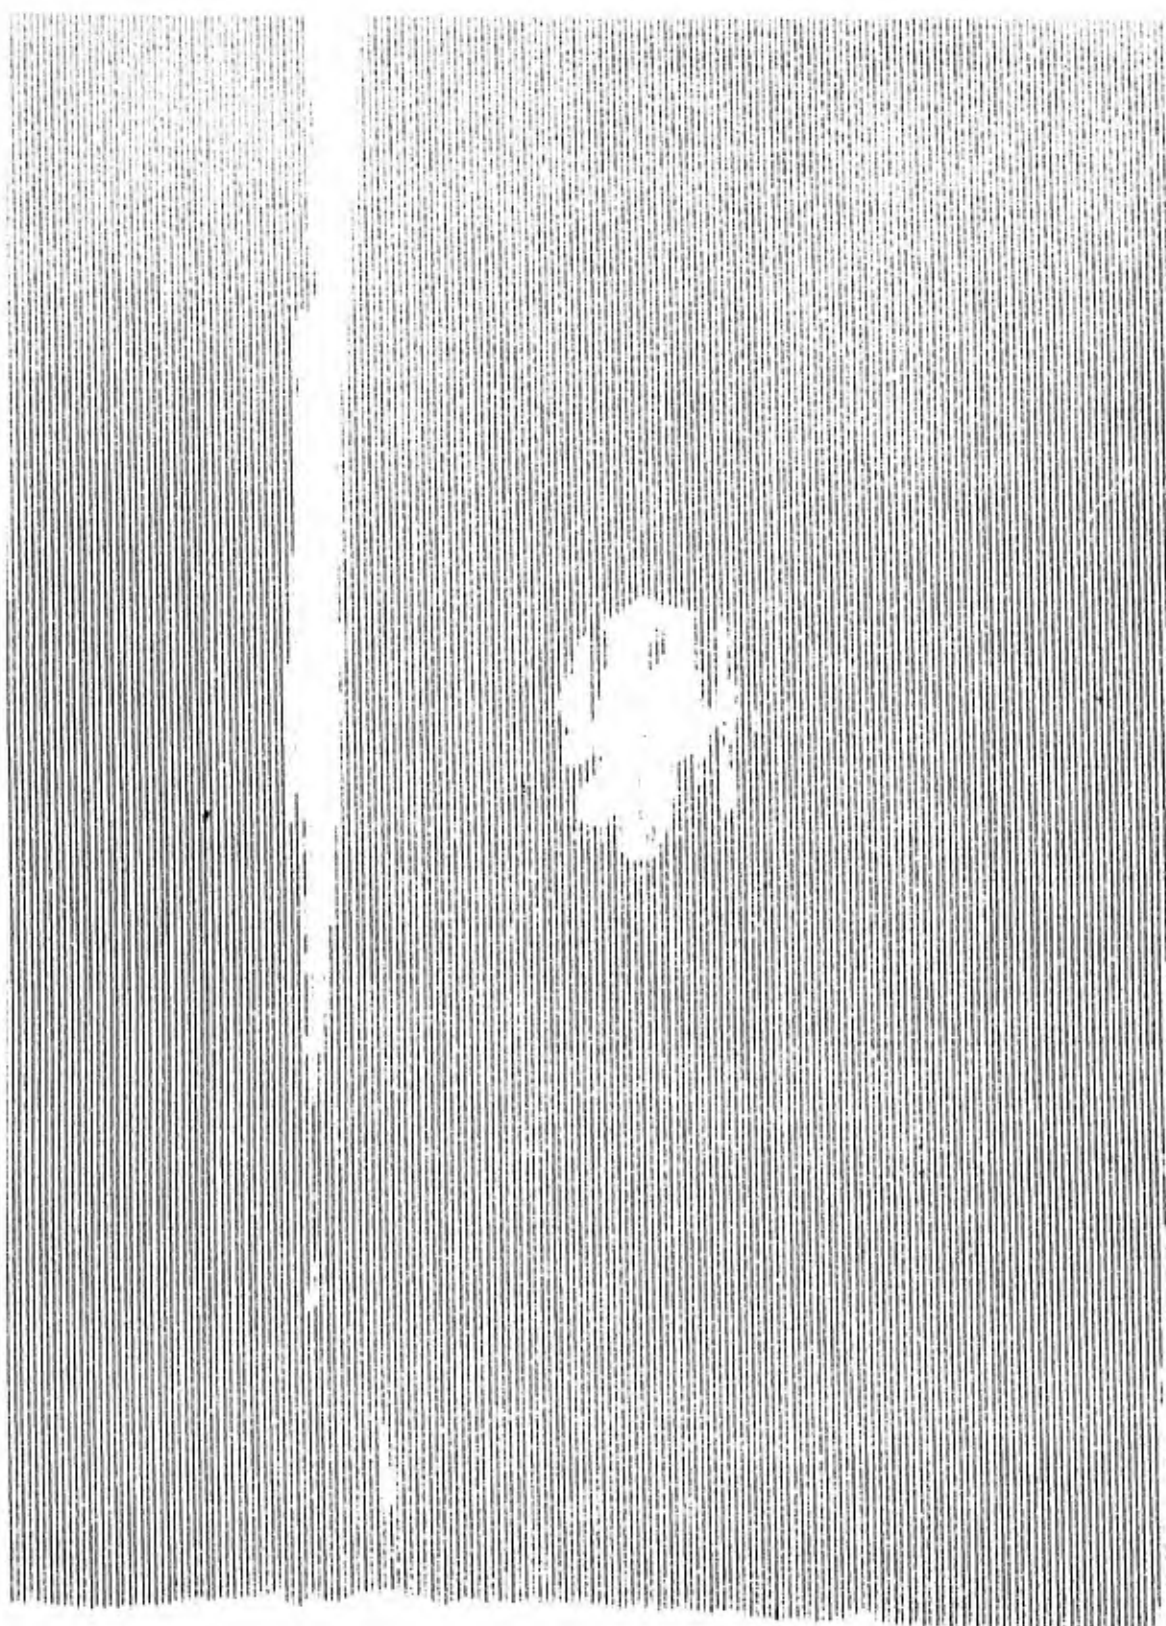
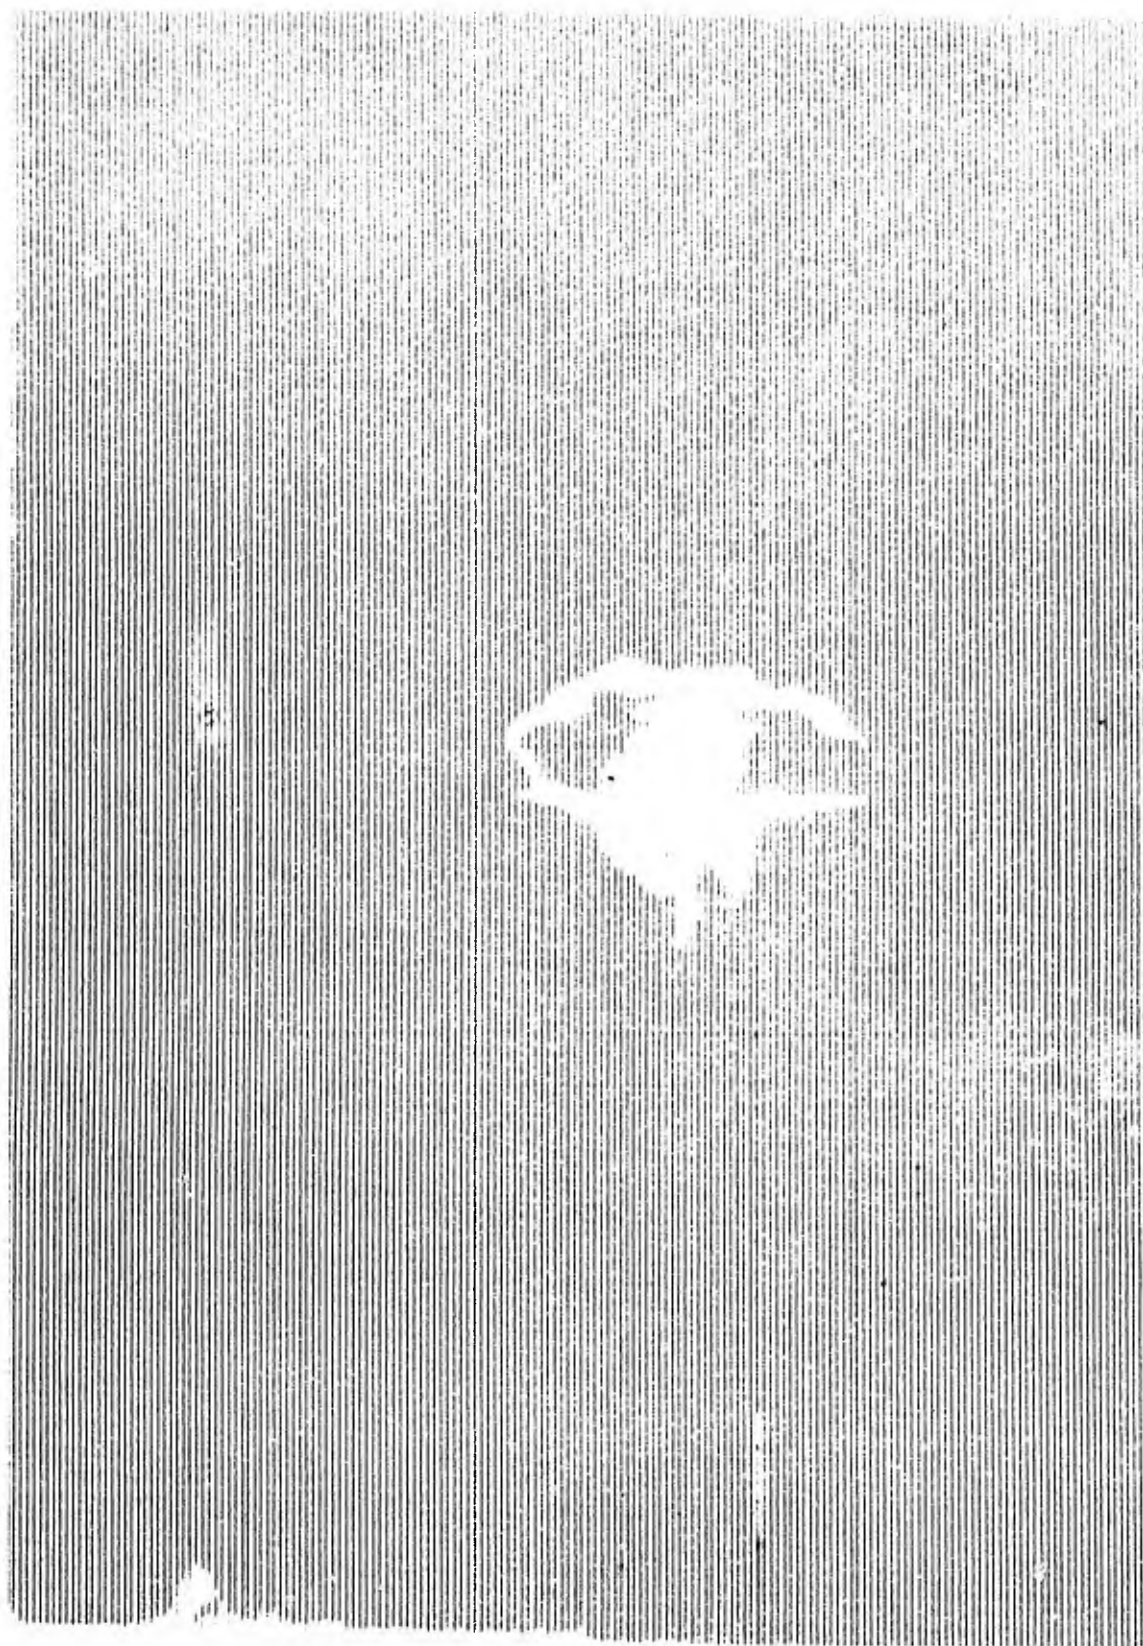
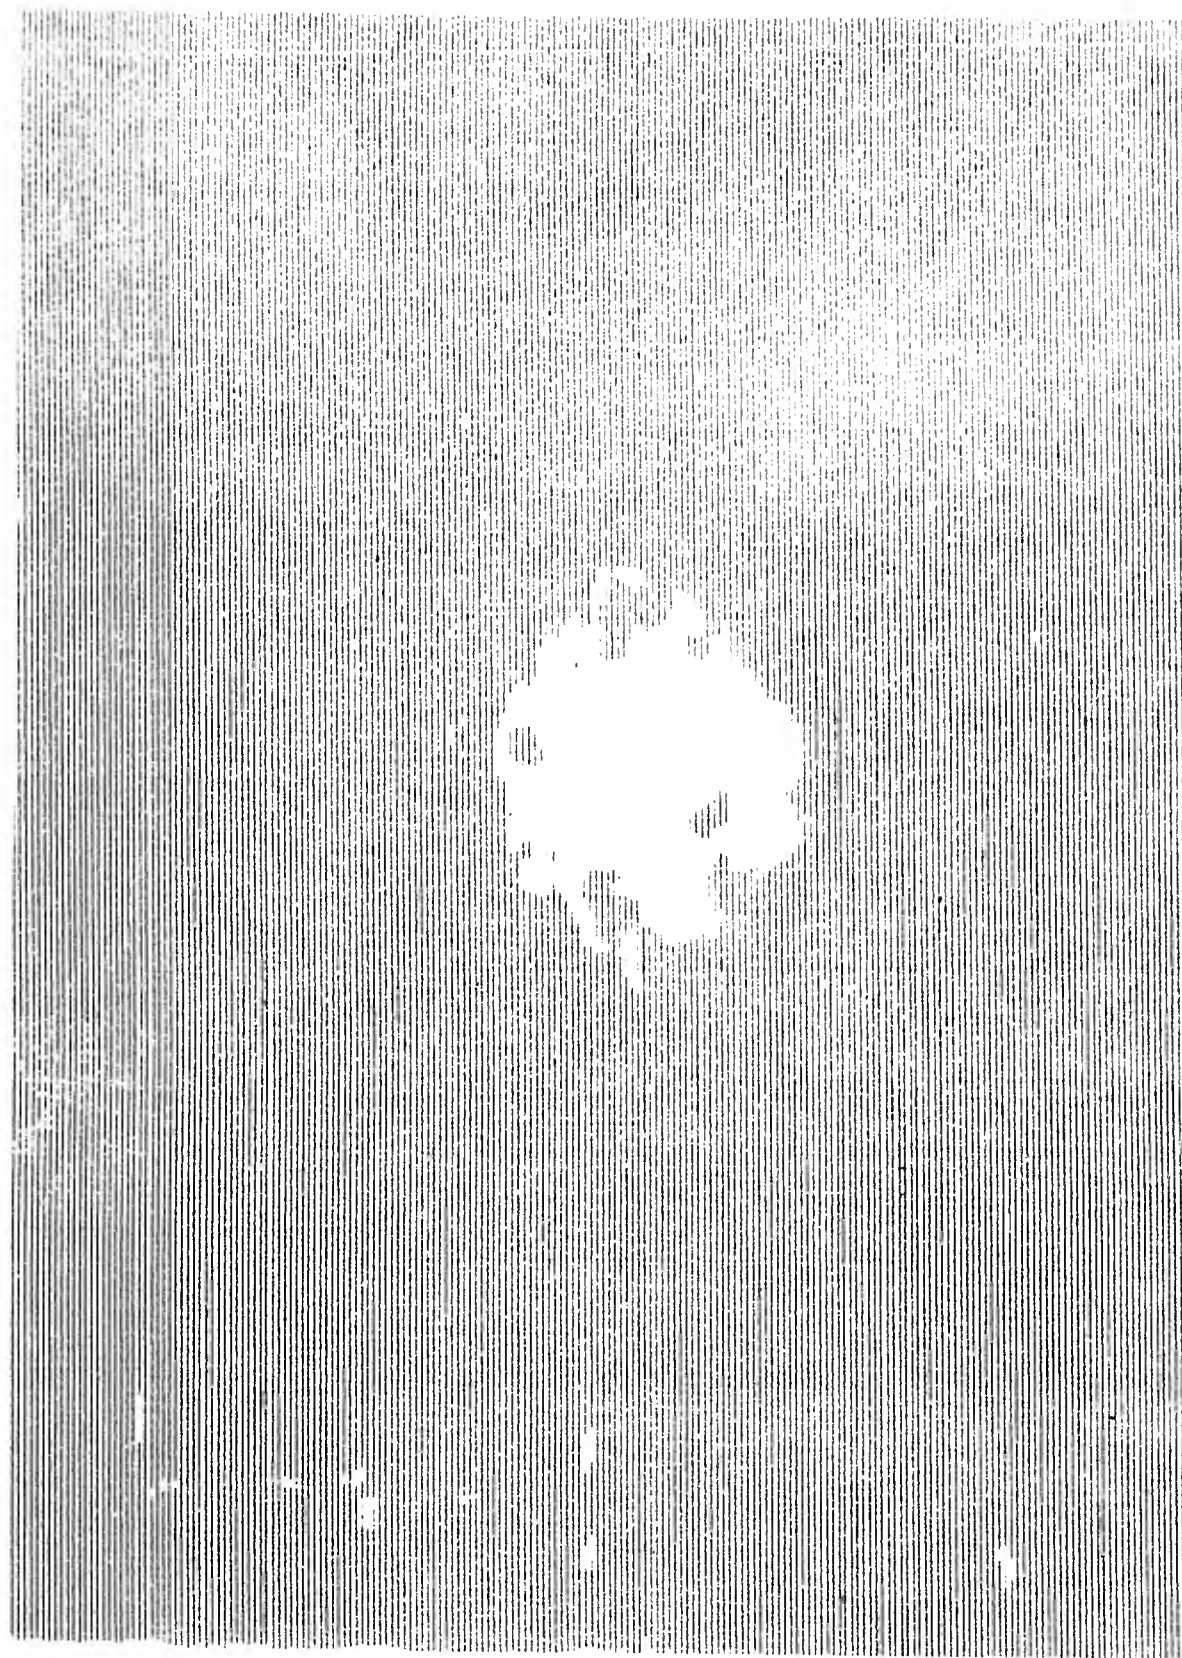
Typical ultrasonic "C"-scan records for the three uncoated graphite panels are shown on Figures 18 through 20. The light coated areas show regions of poor or no ultrasonic transmission. While the damaged areas do show up there are other regions on the panel that seem to show no transmission. A good example is the long white streak to the left of the damaged area on Figure 18. Figure 11, a photograph of the damaged face of the panel, shows a streak on the surface that might be the cause of the poor ultrasonic transmission, but there are other streaks that do not seem to result in regions of poor transmission. Likewise, the damaged area as traced out on the "C"-scan does not tell any more than does visual observation of the damaged area. This same pattern seems to hold throughout the tests. None of the "C"-scans indicated damage that was not readily visible. The area of the white patch on the "C"-scans is more clearly defined than is the damaged area on the surface of the panels themselves and perhaps the area of this region of poor transmission would be a measure of the integrated damage to panels. On the other hand, the "C"-scan technique does not appear to be a really promising tool for investigation for damage in the field.

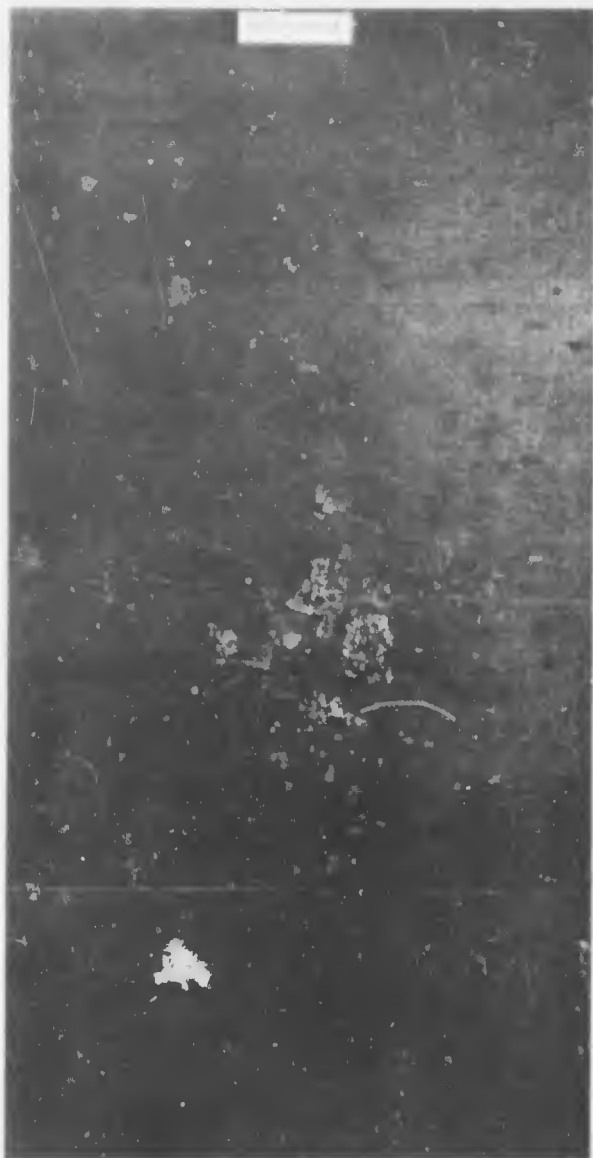
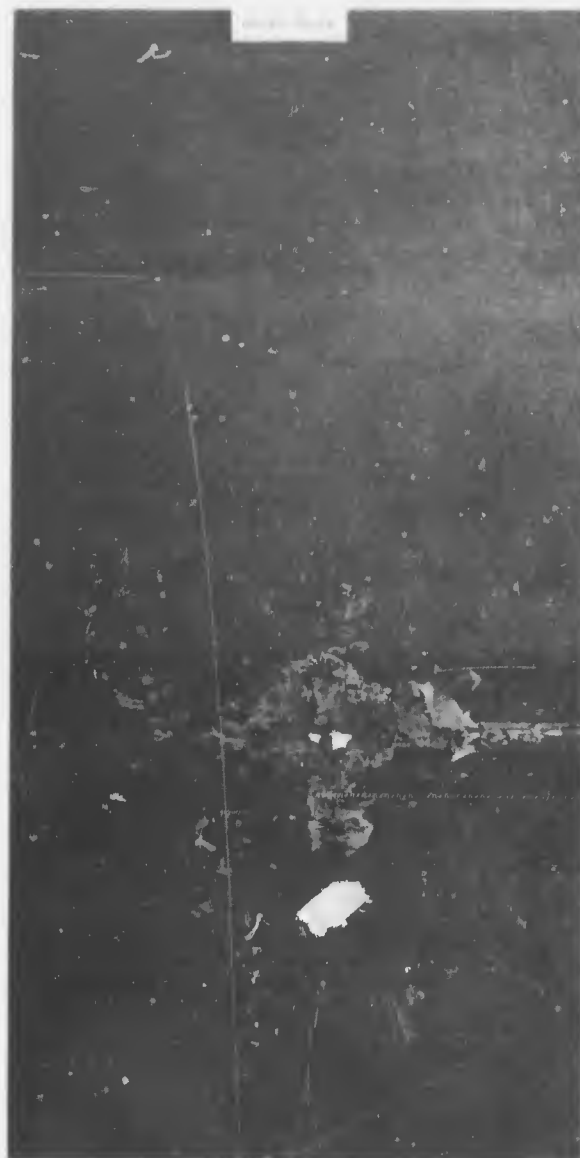
FIGURE 29 - Uncoated Boron Panels After Testing (Front Sides Shown)

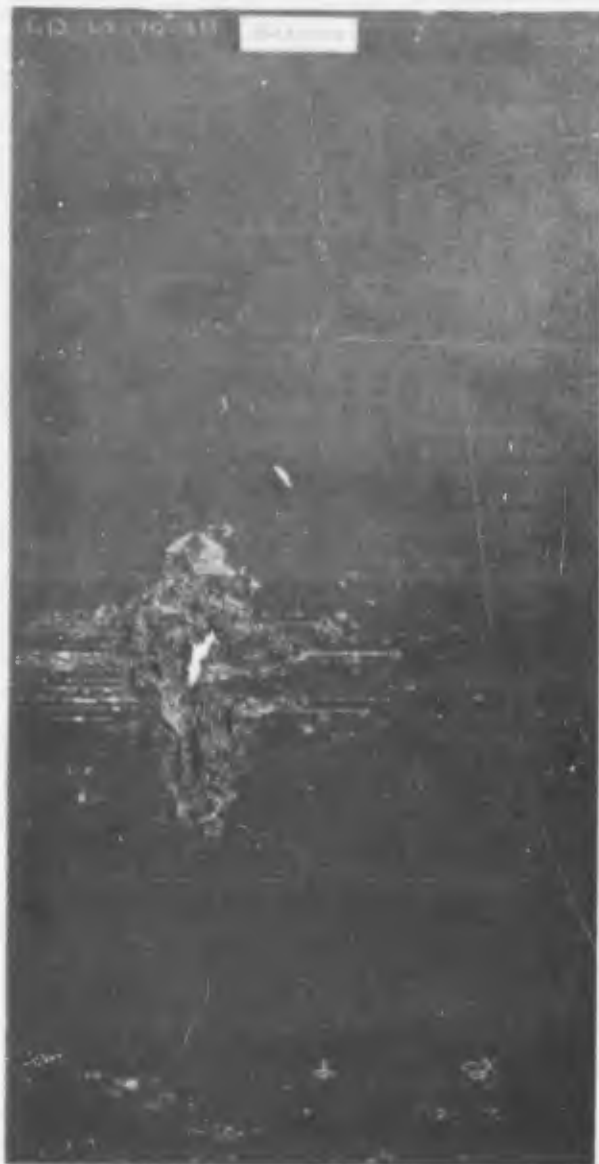
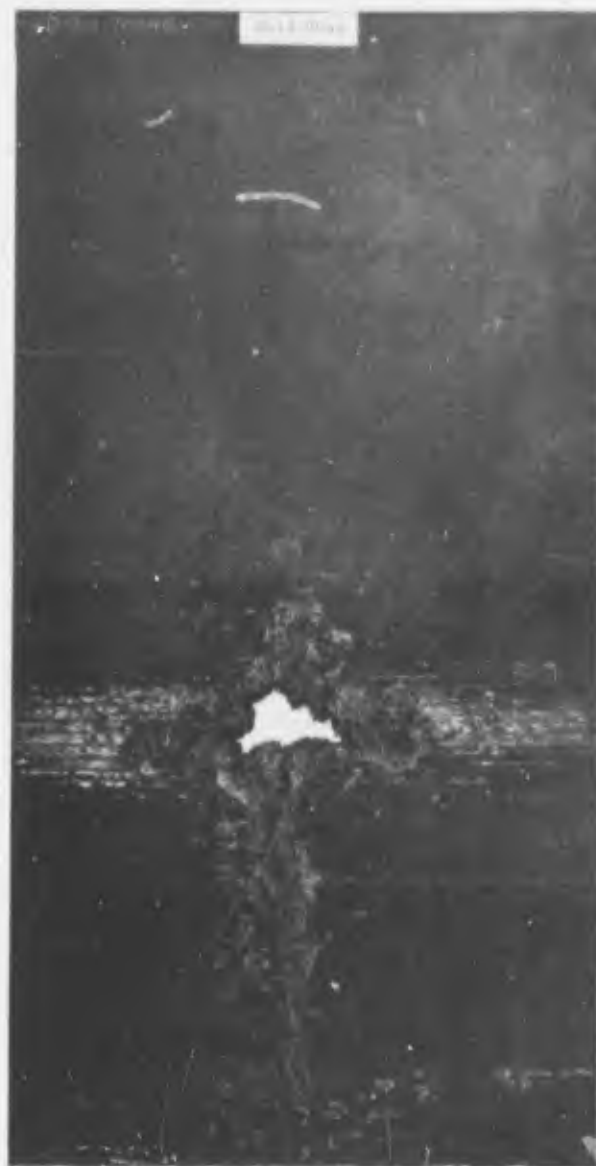
FIGURE 30 - Uncoated Boron Panels After Testing (Front Sides Shown)

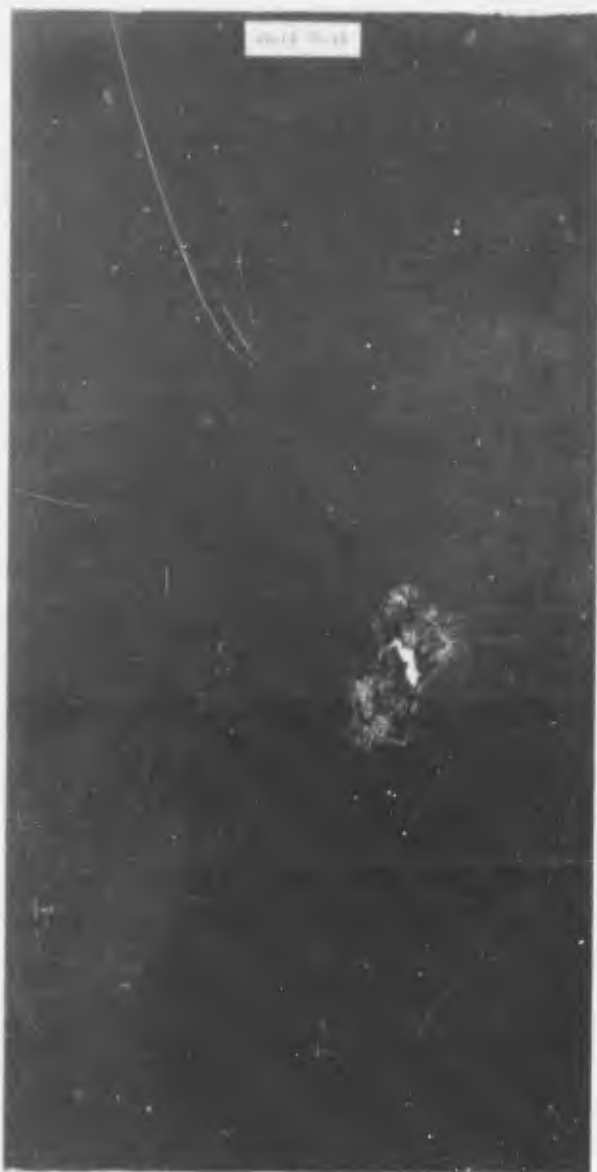
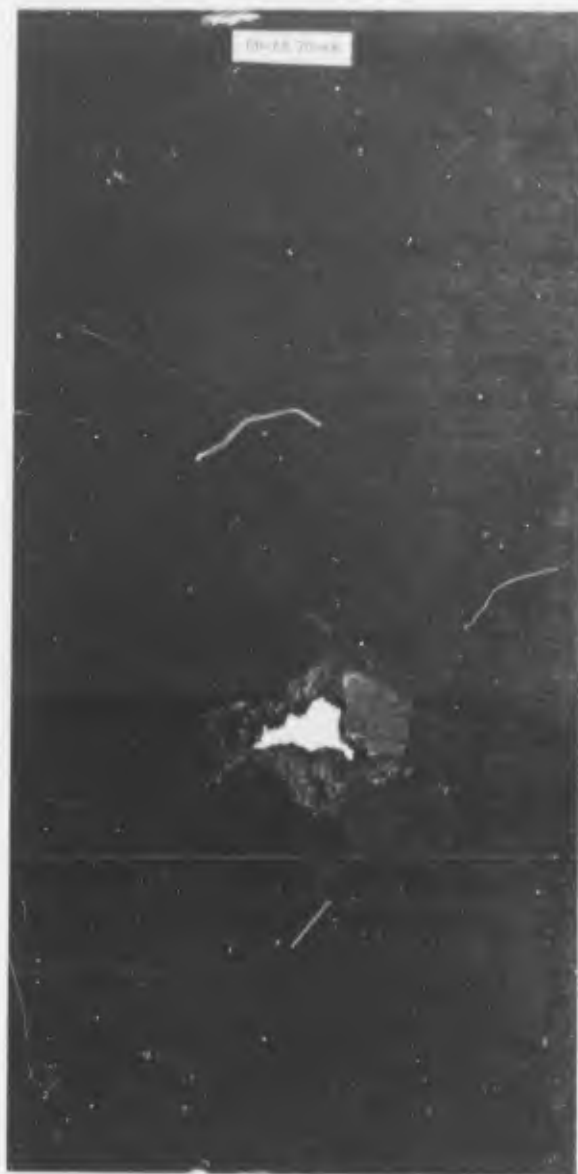
FIGURE 31 - Uncoated Boron Panels After Testing (Back Sides Shown)

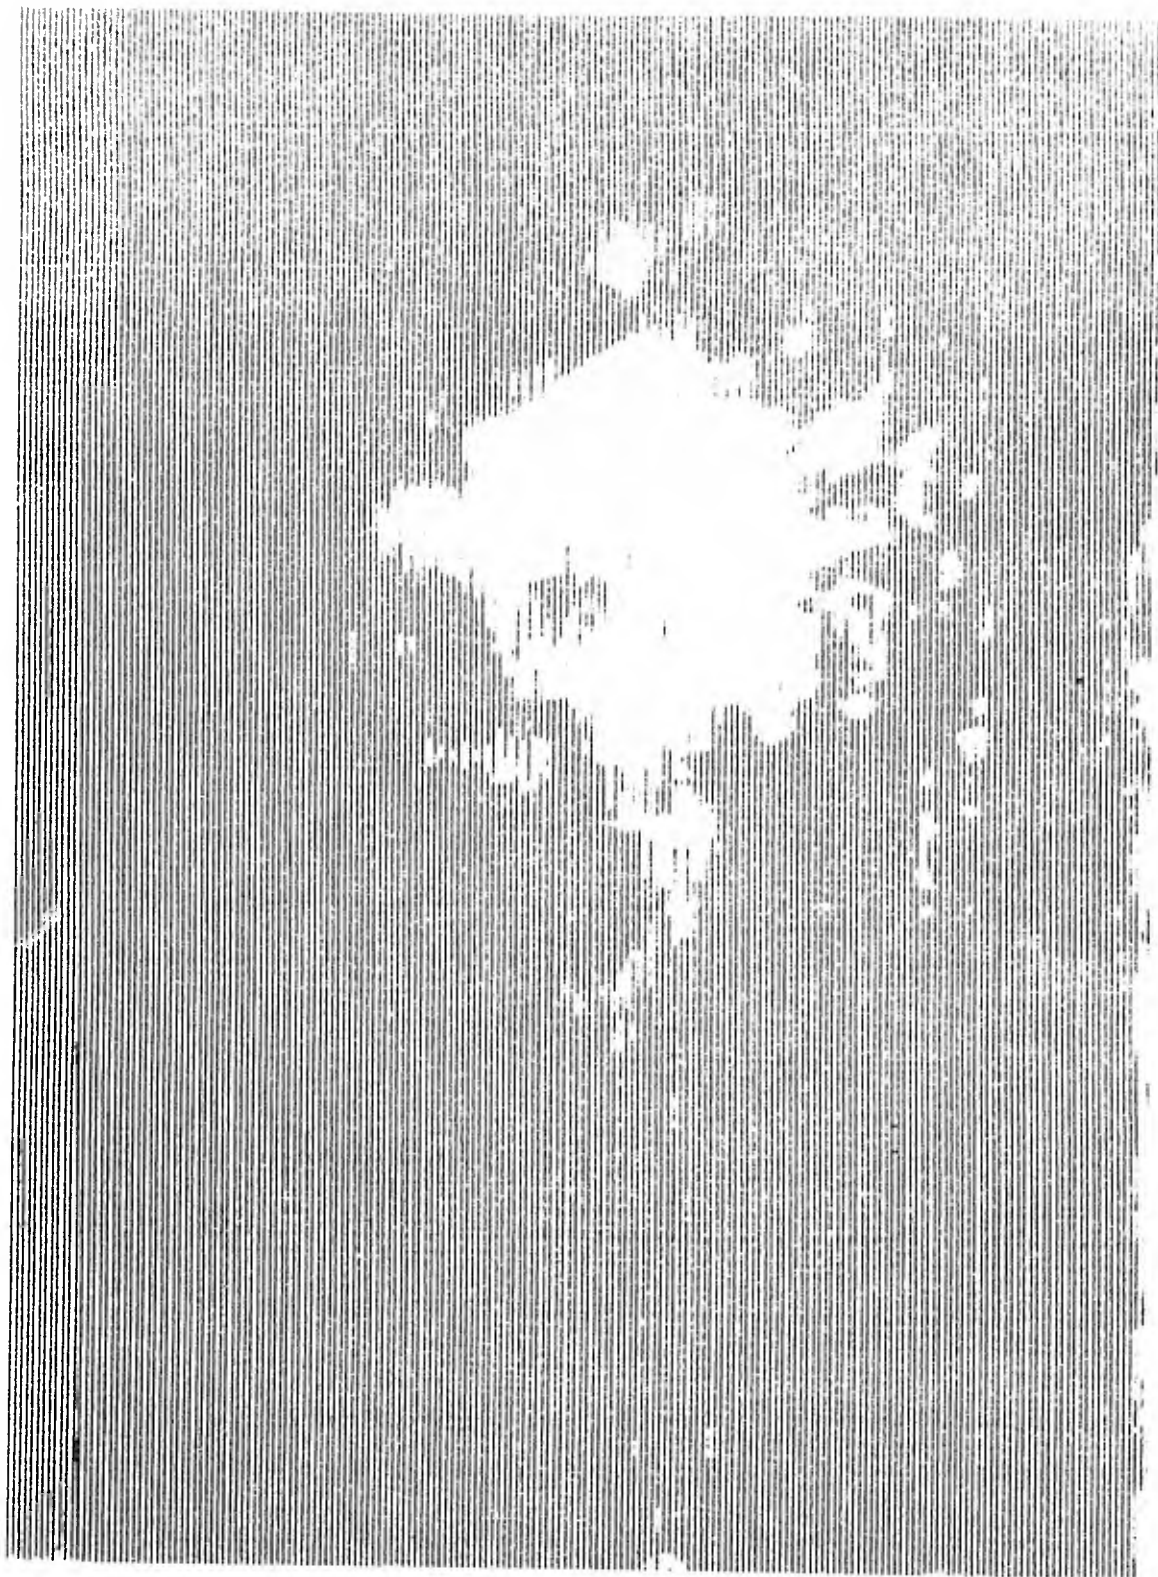
GD-LS-70-1B
(56 kA)

The ultrasonic "C"-scan displays of the damaged regions of the above four panels are shown on Figures 36 through 39. The damaged regions again show as a white area on the pictures, and again do not seem to show damaged regions that were not visually evident from the panels themselves. The area of the display on the "C"-scan pictures can serve as a rough measure of the damaged areas of the panels if one wishes to correlate damaged area to lightning current amplitude.

FIGURE 36 - Ultrasonic "C" Scan of Boron Epoxy Panel After Simulated
Lightning Test

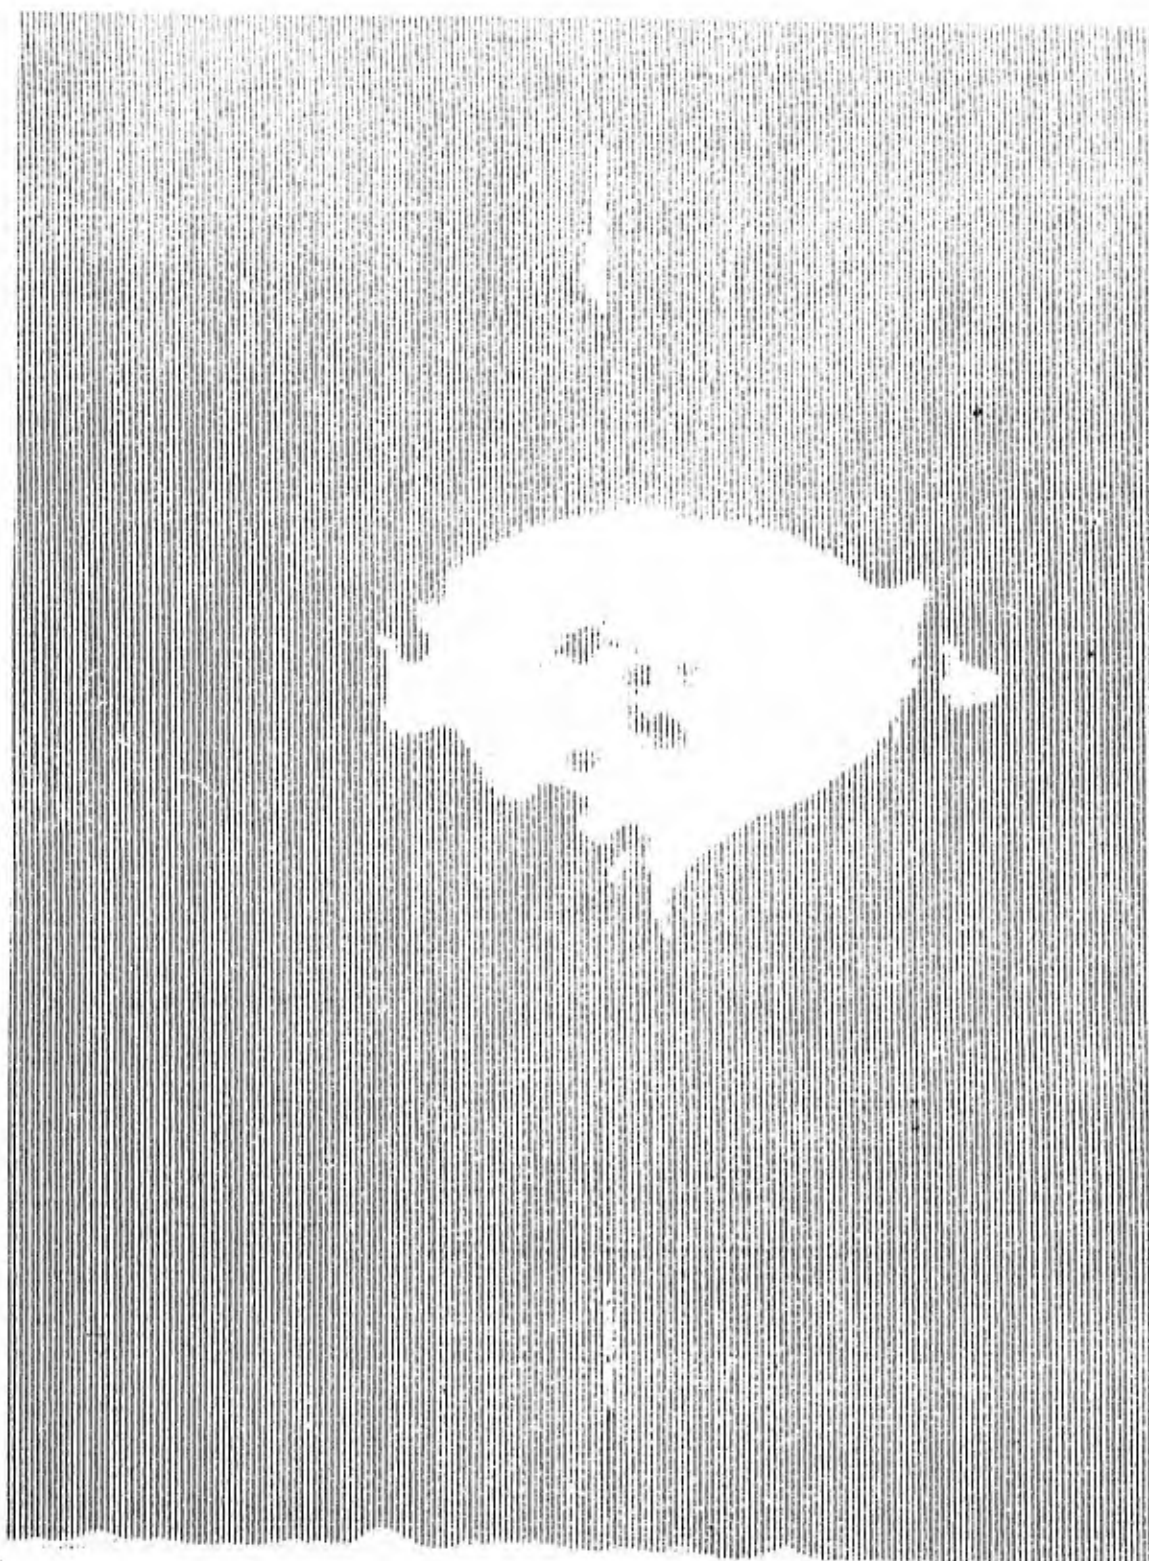
GD-LS-70-2B
(73 kA)

FIGURE 37 - Ultrasonic "C" Scan of Boron Epoxy Panel After Simulated
Lightning Test
